Test Report

Long Range Communication
Stable in Pipe Jungle
Robustness in Wi-Fi Co-existence

Yokogawa performed Field Wireless System site tests compliant with ISA 100.11a, a standard with superior capabilities

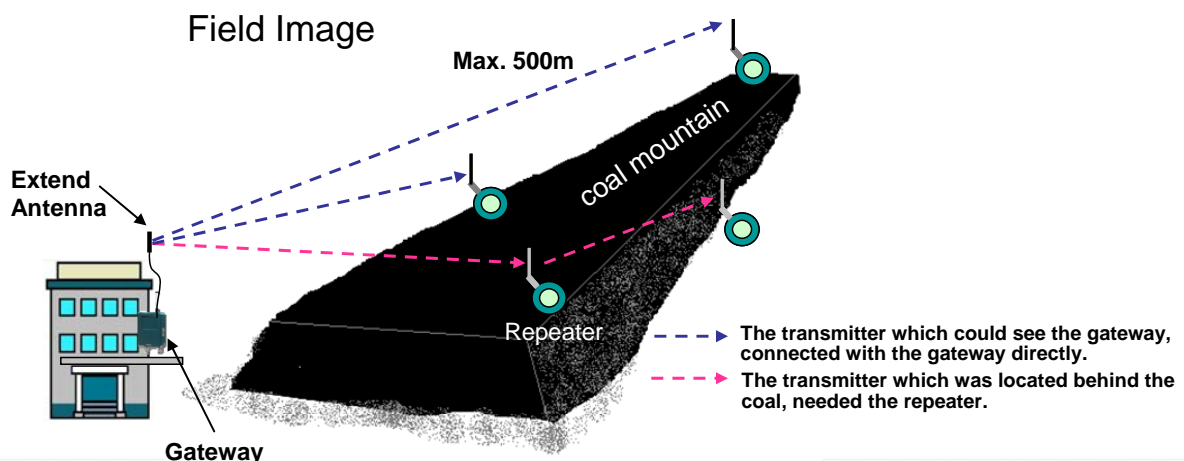
Reliable Wireless Test Report No.0001

- The area was 600x400m storage yard of coal.
- The coal piled up mountain-high was an obstacle of wireless and was not fixed for a long time.
- The loader/un-loader (big mechanical machine) was operating among mountains of coal.
- The customer's requirement of data update interval was 10 seconds or more.

- **Our previous wireless system** needed to deploy three routers (repeaters) between the gateway and the wireless transmitter, which were located at both ends of the area.
- **The ISA100.11a wireless system** could communicate successfully using only one router between them, because the communication range of the ISA100.11a wireless system is wider than our former system.
- The PER's (packet error rate) of all communication paths of the ISA100.11a wireless system were very low (Nearly equal 0%).

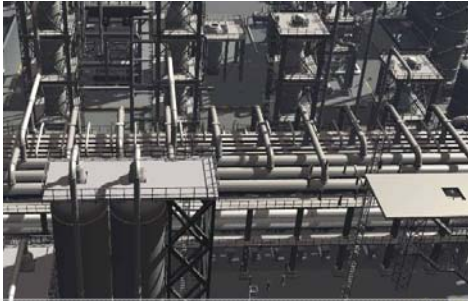
Reliable Wireless Test Report No.0002

- 50m square piping jungle environment (field) in the plant.
- Deployed 7 wireless transmitters in the area.

- **ISA100.11a wireless system** could communicate successfully and all communication paths showed low PER (packet error rate) under 1%.
- **Our previous wireless system** could communicate in the same area. However, the PER was estimated ten times worse than the ISA100.11a wireless system.

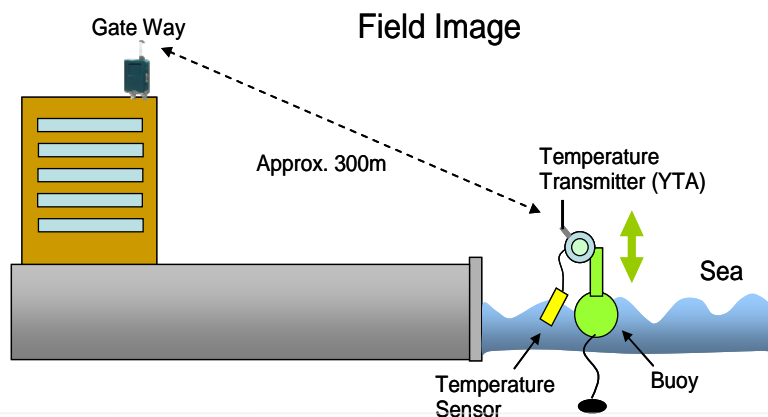
Reliable Wireless Test Report No.0003

- The distance was approximately 300m beside the sluice gate at seashore.
- The most of communication path was on the sea without any obstacles.
- The customer's requirement of data update interval was 10 seconds or more.

- In the case of **the ISA100.11a wireless system** the wireless devices could communicate directly with gateway, because the communication range of the ISA100.11a wireless system is wide.
- The PER's (packet error rate) of all communication paths were very low (Nearly equal 0%).
- **Our previous wireless system** was estimated to need to deploy two or more routers (repeaters) along the seashore to establish the communication.
