Yokogawa performed Field Wireless System site tests compliant with ISA 100.11a, a standard with superior capabilities

Test Report

Reliable Wireless Test Report No.0004

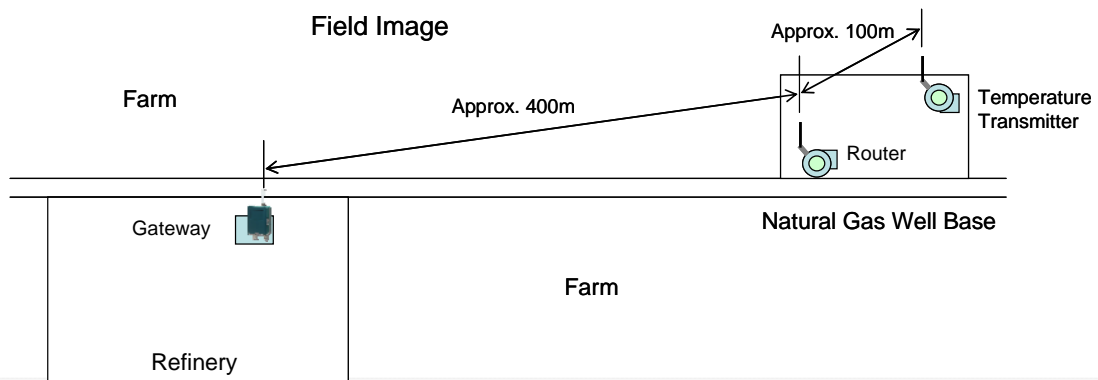
- The distance between natural gas well base and refinery was approx. 400m.
- The well heads were surrounded by grating plates and plaster boards and roofs were covered by steel plates.
- The wireless transmitter was installed in the opposite side of the well head against the repeater. Therefore, the well head might interfere to the communication between the wireless transmitter and the repeater.
- The antennas of the gateway and the router could see each other. However, the antennas of the router and the temperature transmitter couldn't see each other.

- **The ISA100.11a wireless system** could communicate successfully putting only one router between them, because the communication range of the ISA100.11a wireless system is wider than our previous wireless system.
- The PER's (packet error rate) of all communication paths of the ISA100.11a wireless system were very low (Nearly equal 0%).
- **Our previous wireless system** was estimated to need to deploy three routers (repeaters) between the gateway and the wireless transmitter located at the both ends of the area.

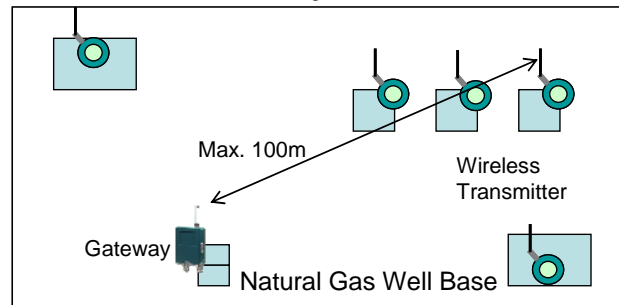
Field Image

- The maximum distance between gateway and wireless transmitters were 100m.
- The well head was surrounded by grating plates and plaster boards and the roof was covered by steel plate.
- The wireless transmitter was installed in the opposite side of the well head against the repeater. Therefore, the well head might interfere to the communication between the wireless transmitter and the repeater.
- The antennas of router and temperature transmitters couldn't see each other.
- The well heads (three points) and heating facilities (two points) were the area of dense metal objects.

- **The ISA100.11a wireless system** could communicate successfully with the gateway directly, because the communication range of the ISA100.11a wireless system is wider than our previous wireless system.
- The PER's (packet error rate) of all communication paths of the ISA100.11a wireless system were very low (Nearly equal 0%).
- The process data publication at every second was performed stably.

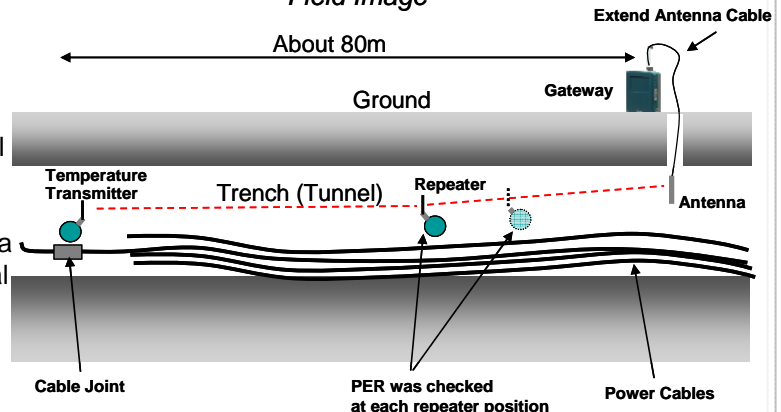
Field Image

- The distance between the wireless transmitter and the gateway was approx. 80m.
- The wireless equipments were installed in the trench with cross section of 2.5mx2.5m.
- Many high tension power cables were lying on both side of wall supported by metal brackets. Actual width where the line of sight was secured was approx. 1.5m.
- The customer's requirement of data update interval was 60 seconds.

- **The ISA100.11a wireless system** could communicate successfully using one router between them, although the multi-pass phasing which was caused by strong reflection from wall and metal objects existed.
- The PER's (packet error rate) of all communication paths of the ISA100.11a wireless system were low (Nearly equal 0%).
