Yokogawa performed Field Wireless System site tests compliant with ISA 100.11a, a standard with superior capabilities

Test Report

Reliable Wireless Test Report No.0007

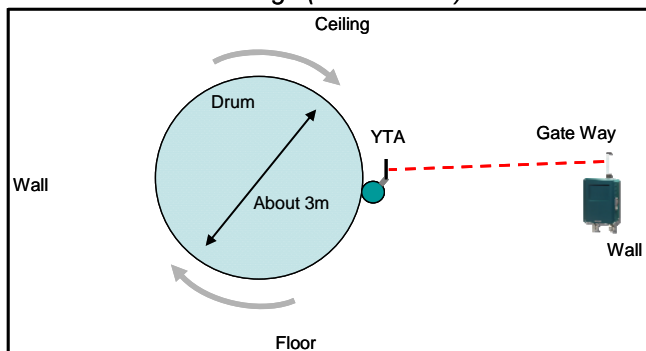
Field Image (Side of View)

- The wireless transmitter was installed on a rotary kiln in the room surrounded by wall. The diameter of kiln was 3m and the length was approx. 10m.
- The distance between the wireless transmitter and the gateway was minimum 3m.
- The period of rotation was 150 seconds. The customer's requirement of data update interval was 60 seconds.

- **The ISA100.11a wireless system** could communicate successfully. The reflection of wall, ceiling, and floor in such narrow area enabled the communication, because the receiver function is superior to realize almost 0% of PER (packet error rate).
- The PER of communication path of the ISA100.11a wireless system was very low (Nearly equal 0%).

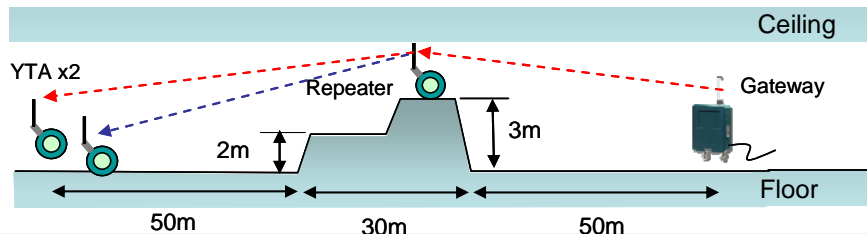
Field Image

- The distance between wireless transmitters and gateway was approx. 130m. A stepped stage existed between the wireless equipments.
- The wireless pass was got narrow by the stepped stage and ceiling and the communication was interfered.
- The customer's requirement of data update interval was 60 seconds or more.

- **The ISA100.11a wireless system** could communicate successfully using only one router between them, because the receiver function is superior to realize almost 0% of PER (packet error rate).
- The PER's (packet error rate) of all communication paths of the ISA100.11a wireless system were very low (Nearly equal 0%).

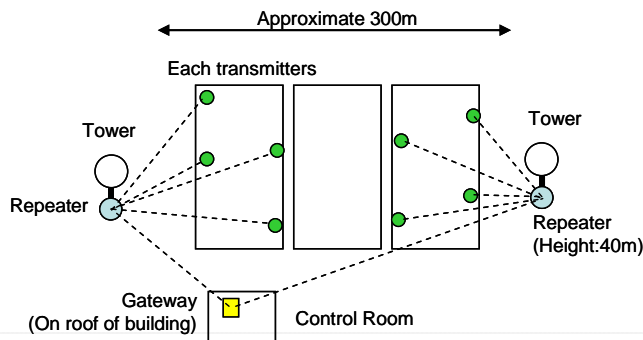
Field Image (Top of View)

- The wireless transmitters were installed instead of the temperature and pressure gage in the inside of several plants.
- The distance of between wireless equipments was maximum 300m.
- The customer's requirement of data update interval was 10 seconds or more.

- **The ISA100.11a wireless system** could communicate successfully using only one router between them in both plants, because the communication range of the ISA100.11a wireless system is wider than our former system. Consequently, one gateway could communicate with all of the wireless transmitters.
- The PER's (packet error rate) of all communication paths of the ISA100.11a wireless system were very low (Nearly equal 0%).
- **Our previous wireless system** was estimated to need to deploy more routers (repeaters) between the gateway and wireless transmitters or to need to be divided to two wireless networks.
