**Yokogawa performed Field Wireless System site tests compliant with ISA 100.11a, a standard with superior capabilities**

**Reliable Wireless Test Report No.0010**

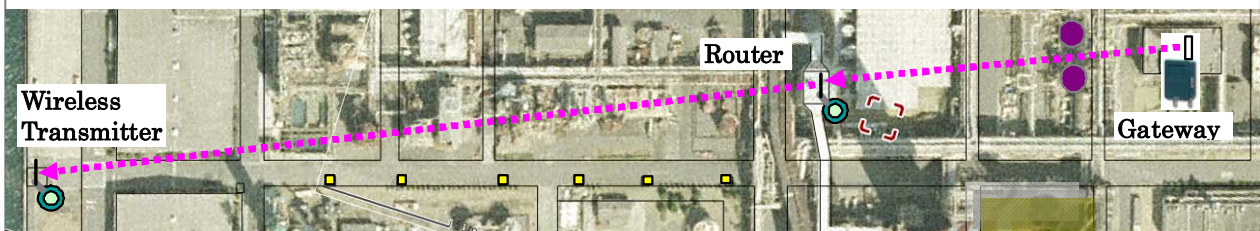
### Field image

- The measuring point was at the edge of the plant area beside the seashore. The distance between the wireless transmitter and the gateway was approximately 600m. The wireless transmitter and the gateway could not see each other.
- There were two tool towers, one was a heat exchanger, on the wireless route. Some obstacles existed between the router and the wireless transmitter.
- The customer's requirement of data update rate was 10 seconds or more.

- In the case of **the ISA100.11a wireless system** the wireless devices could communicate with the gateway via only one router, because the communication range of the ISA100.11a wireless system is wide.
- **Our previous wireless system** needed routers (repeaters) at two places between the router and the wireless transmitter.

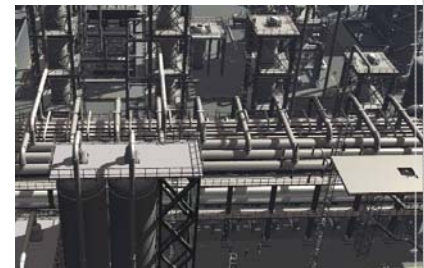
- The plant was indoor, the area of the floor of the building was 110x60m and the height was 25m.
- The building had five floors and the floors were covered by metal grating plates.
- All wireless equipments were installed in the dense obstacles area.
- Tests were executed in the following conditions:  
Wireless equipments were installed on the same floor, putting obstacles between equipments.  
Wireless equipments were installed on different floors, putting the floor covered by grating plates between them.

- **The ISA100.11a wireless system** could communicate successfully and almost all communication paths showed low PER (packet error rate) under 1%, because the receiver function is superior to realize almost 0% of PER.
- The stable communication path was established not only in the condition that both wireless equipments were installed on the same floor, but also in the condition that they were installed on different floors such as the fourth floor and the first floor.

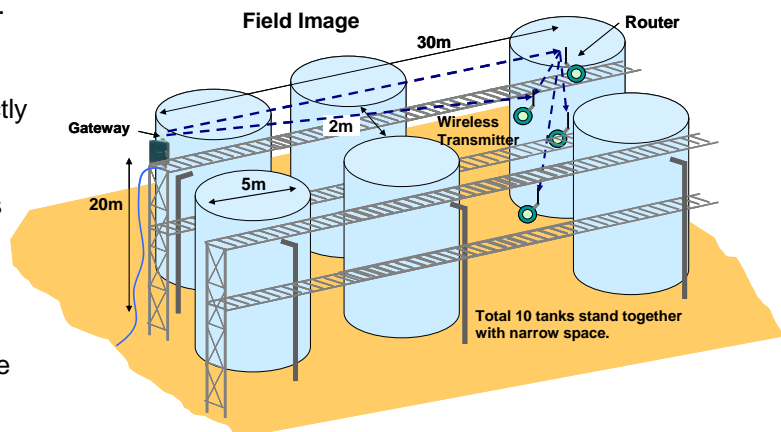
- The plant had ten tanks in 60x25m area. The heights of the tanks were 20m.
- Passageways (covered by the grating plate), piping racks, and cable racks were laid beside the tanks.
- Wireless transmitters were installed at three different heights on the tanks.
- All wireless equipments were installed in the dense obstacles area.

- **The ISA100.11a wireless system** could communicate successfully and almost all communication paths showed low PER (packet error rate) under 1% via the router, because the receiver function is superior to realize almost 0% of PER.
- The wireless transmitters which were installed in the middle and highest portion also could communicate directly with the gateway with low PER, even though many obstacles such as passageways, piping and cable racks existed.
- The wireless transmitters which were installed in the lowest portion (60cm from the ground) could communicate with the gateway with low PER via the router.
