Yokogawa performed Field Wireless System site tests compliant with ISA 100.11a, a standard with superior capabilities

Test Report

Reliable Wireless Test Report No.0016

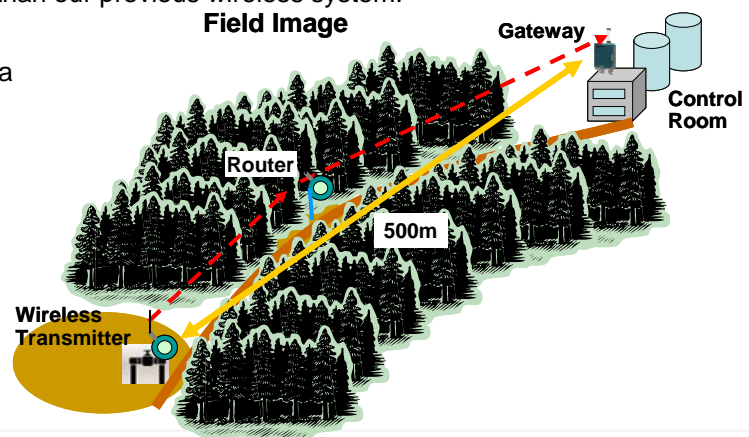
- The wells of salt water pumping were dotted in deep jungle. The trees in the jungle were higher than 12m and strong obstacles for wireless communication.
- The distance between the wireless transmitter and the gateway was approximately 500m.
- The process values were transmitted along the 2m width road laid in the jungle. The wireless transmitter and the gateway couldn't see each other.
- The customer's requirement of data update interval was 10 seconds or more.

- **The ISA100.11a wireless system** could communicate successfully between the wireless transmitter and the gateway using only one router along the road, because the communication range of the ISA100.11a wireless system is wider than our previous wireless system.
- The PER (packet error rate) of all communication path of the ISA100.11a wireless system was very low (nearly equal 0%).
- **Our previous wireless system** was estimated to need two routers (repeaters) between the wireless transmitter and the gateway.

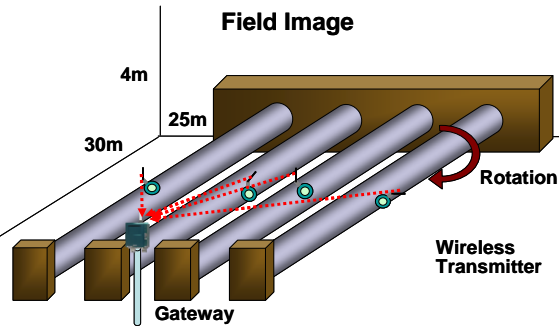
- The wireless transmitter was installed on a rotary kiln. Four kilns which were 3m diameter and 20m long were located in a room where the floor was 30mx20m and the roof height was 4m. The diameter of kiln was 2m and the length was approx. 20m.
- The gateway was installed in the center of the room. The maximum distance between the wireless transmitter and gateway was 25m.
- The period of rotation was 160 seconds. The customer's requirement of data update interval was 5 seconds.

- **The ISA100.11a wireless system** could communicate successfully. The communication was enabled by the reflection of wall, ceiling, and floor in such narrow area, because the receiver function is superior to realize very low PER (packet error rate).
- The PER of all communication path of the ISA100.11a wireless system was low (2% or less).

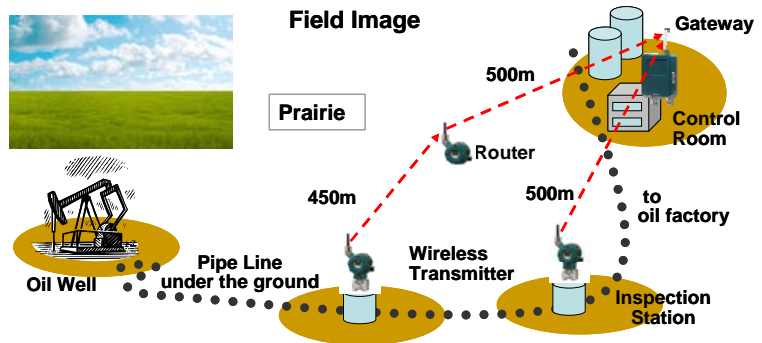
- Oil wells were located in a prairie. All the oil/gas wells were connected by underground pipeline to collect condensate oil and pump it to a plant. The inspection equipments were spread out on the pipeline to measure the pipeline stacking.
- The customer's requirement of data update rate was 10 seconds.

- **The ISA100.11a wireless system** could communicate successfully using the minimum routers between the wireless transmitter and the gateway, because the communication range of the ISA100.11a wireless system is wider than our previous wireless system.
- The PER (packet error rate) of all communication path of the ISA100.11a wireless system was very low (1% or less).
- **Our previous wireless system** was estimated to need more routers between the gateway and the wireless transmitter.
